Air force surveys in geophysics

Investigations of ice-free sites for aircraft landings
in East Greenland, 1959

Joseph H. Hartshorn

September 1961

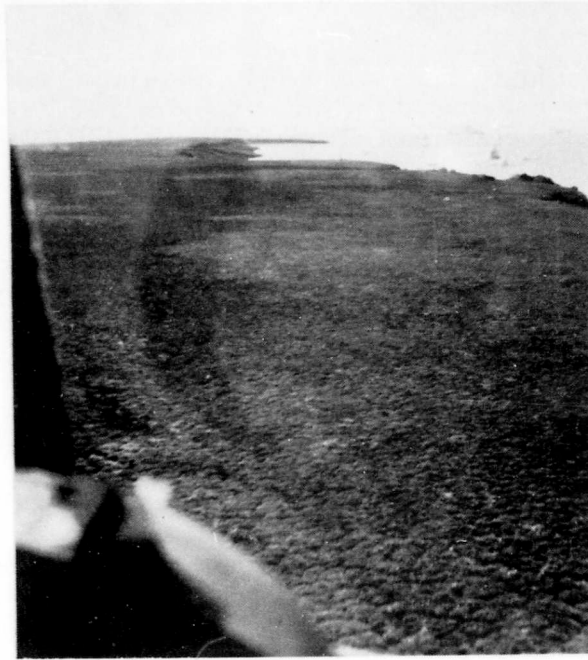
Photograph 4. Aerial view southward of the Nordøst Fjord Site (#7) from an elevation of about 100 feet. Soil hummocks hazardous to landings unless covered by at least 6 inches of snow. Large icebergs in Nordøst Fjord (right) and Hall Bredning (left) are visible in background. Date: 19 August 1959.

Slope and microrelief. The surface is fairly flat, with one or two gentle rolls less than 5 feet deep within a horizontal distance of 200 to 300 feet. The surface is covered by soil hummocks 2 to 3 feet in diameter and about 6 inches high, separated by narrow depressions in which bare ground is exposed (Photograph 4). These hummocks would make any landing hazardous unless the tops of the hummocks were covered by at least 6 inches of snow, in which case ski-landings would be feasible. There is a possibility that strong winds considerably reduce snow cover on the site area in winter.

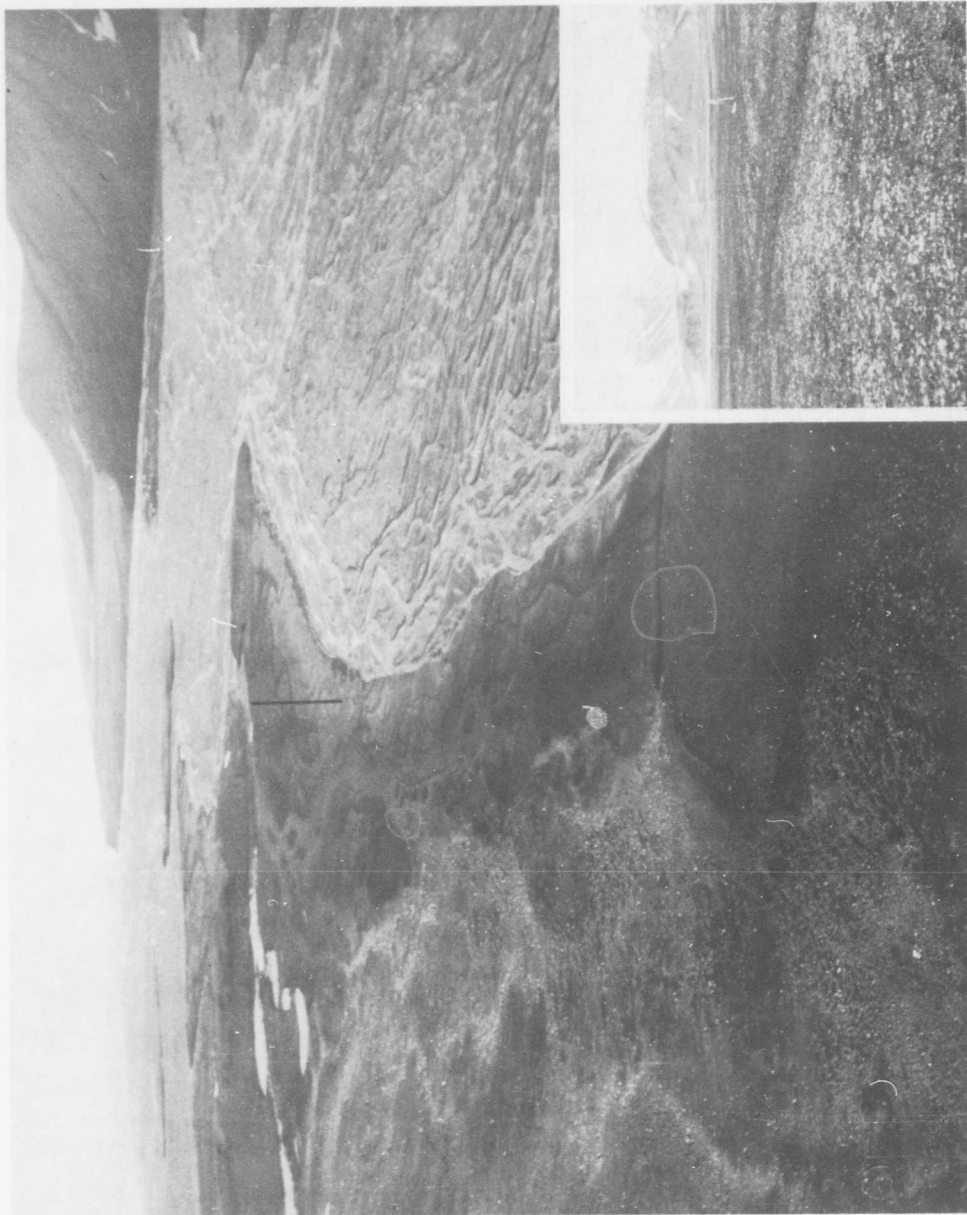
Photograph 9. Ground and aerial views of the Jaettedal airstrip (Site #2). Aerial view is southwest toward Rosenvinge Bugt, showing location of centerline. Ground view is along the centerline from near the south end. The range poles mark the centerline; the flags mark the edges. The site is smooth and free of microrelief features with the exception of shallow swales, such as the one shown in the foreground, about 6 inches lower than the predominant level of the landing strip. However these are nearly parallel to the runway and would not impede landings and takeoffs. View northeast. Date: 21 August 1959.

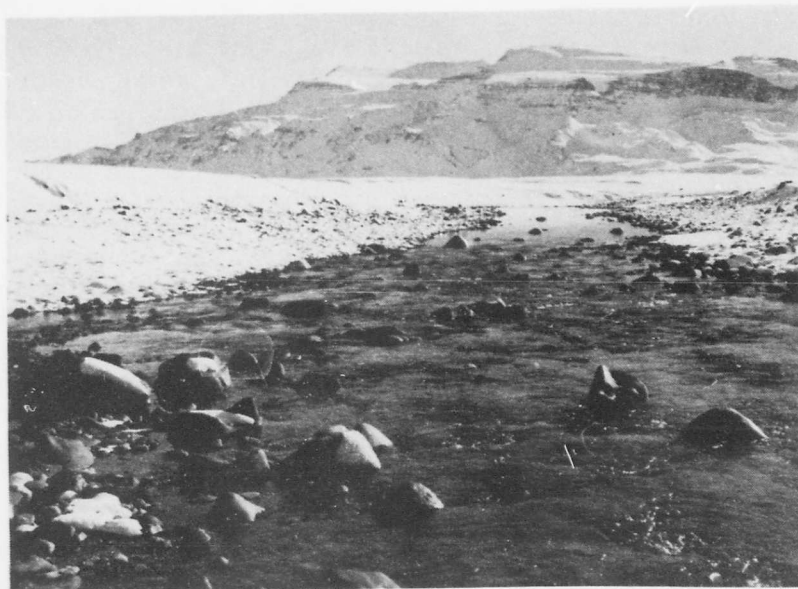
Photograph 16. Storelv at period of low discharge (early September). View south in the narrows 1 1/2 miles southwest of the campsite and 1 mile downstream from Sampling Site 34. The river and its tributaries are good sources of drinking water in summer, but in winter would probably be completely frozen. Date: 3 September 1959.

Storelv is located less than 500 feet from either the northwest end of the proposed landing strip, from the campsite and cache, or from either of the two short landing strips. The river is a good source of drinking water in summer (Photograph 16), but in winter would probably

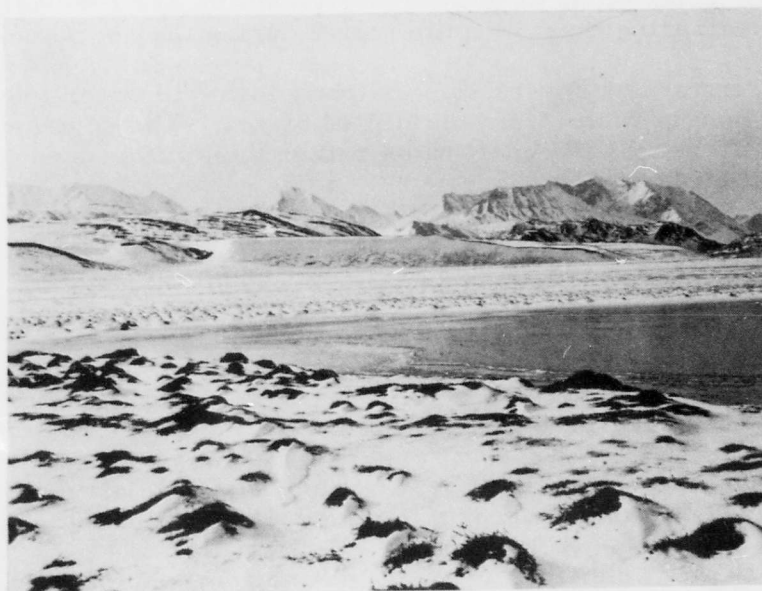
Photograph 17. Pond on outwash terrace near Storelv, the site of Water Sample 35. View west-northwest from a point about 1/2 mile WNW of the Storelv campsite. Date: 5 September 1959.
